**Civil Aviation Organization
Accident Investigation and Analysis Office**

Final Investigation Report of the accident on January 9th, 2011 of a Boeing 727-286, registered EP-IRP, belonging to Iran Air, which crashed in Urmia, Iran.

Finished on December 9th, 2012

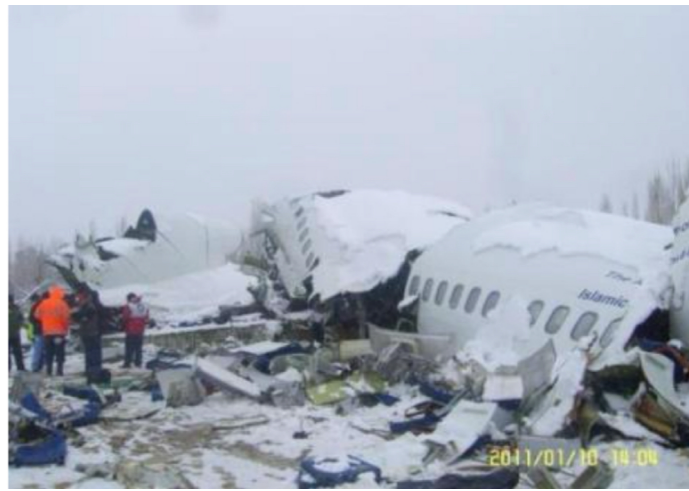
The following sections are identified in the image above:

5. The rear section, located in front of the wings, where the intake of Engine No. 2 was positioned. It was found approximately 1 meter away from the main wreckage at coordinates:
N 37°33.165 - E 045°09.948

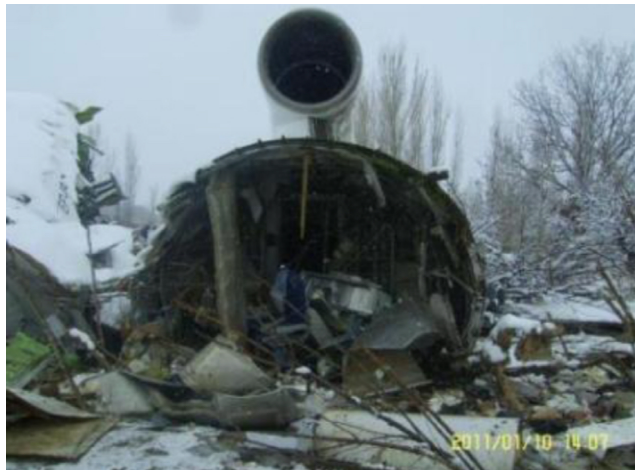
Section No. 5 is identified in the image above.

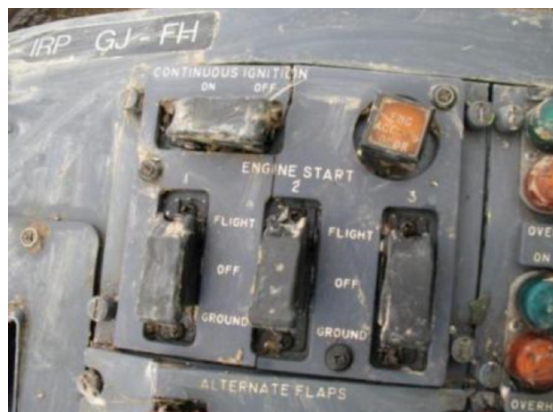
The above diagram illustrates the status of the Continuous Ignition and Engine Start Switches after the accident.

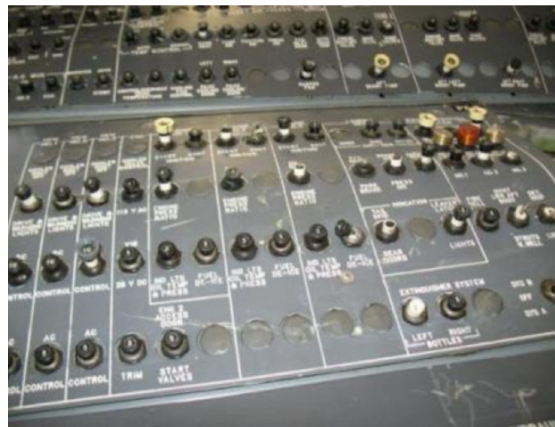
The systems investigation team of the accident review committee has explained the cause and mechanism of the POP OUT of the circuit breakers (CBs) in their report. The diagram below also highlights these CBs.

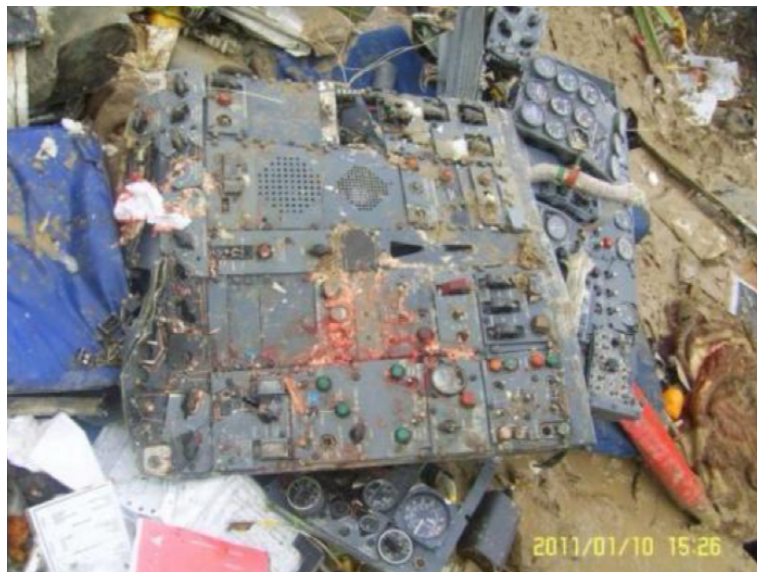
The next image also shows the aforementioned switches after the occurrence of the accident:

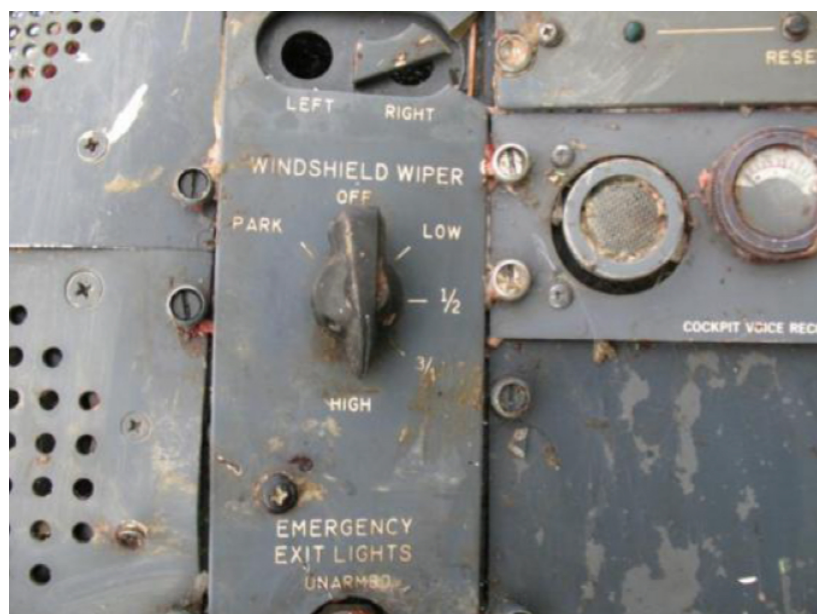
The image below shows the position of the wipers switch (set to high) after the incident.

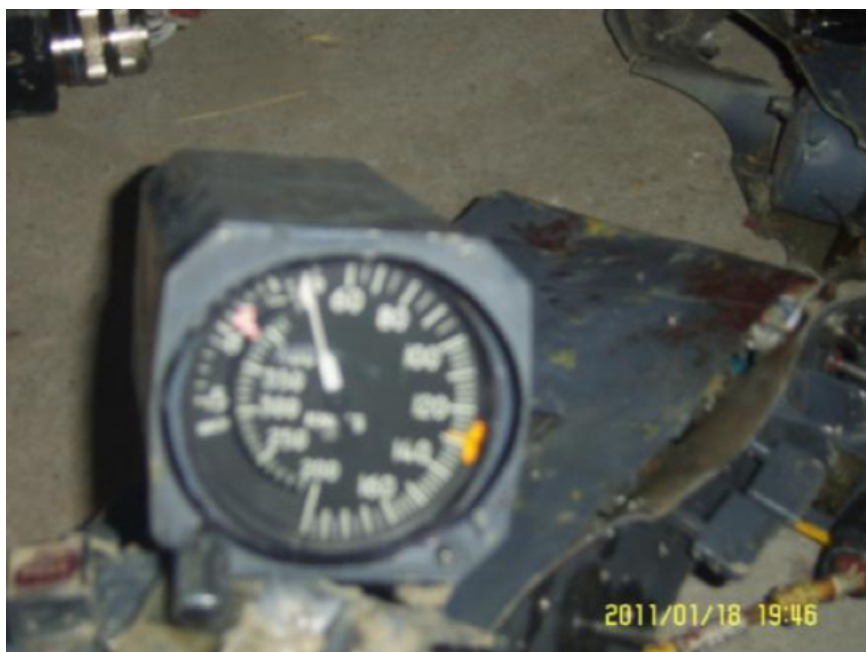
The next image also shows that the pilot has set the speed bug on the Airspeed Indicator to 128 KT for Vref (landing reference speed), based on the flight engineer's calculations. This indicates that the correct speed has been calculated.

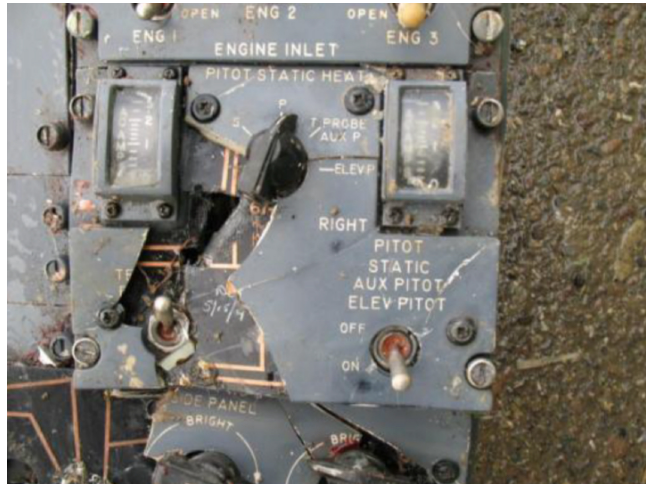
2. The following image shows the status of the Pitot Static Heat system during the incident:

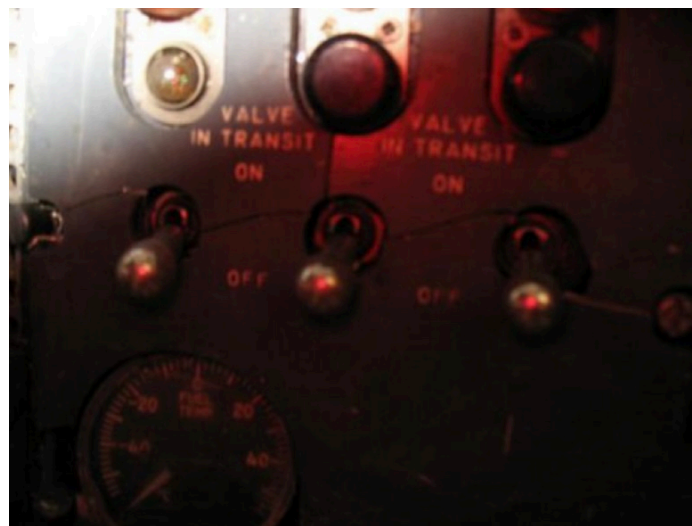
Since the aircraft was in the Go-Around phase, these switches should have been in the OFF position, as shown in the image below.

The image above shows that the Fuel Heat system for all three engines was in the OFF position. However, it is not clear whether this system was turned ON during the flight, as it is not heard on the CVR (Cockpit Voice Recorder). Therefore, according to Safety Bulletin No. 363 dated 12/21/89, this must be called out in the future.

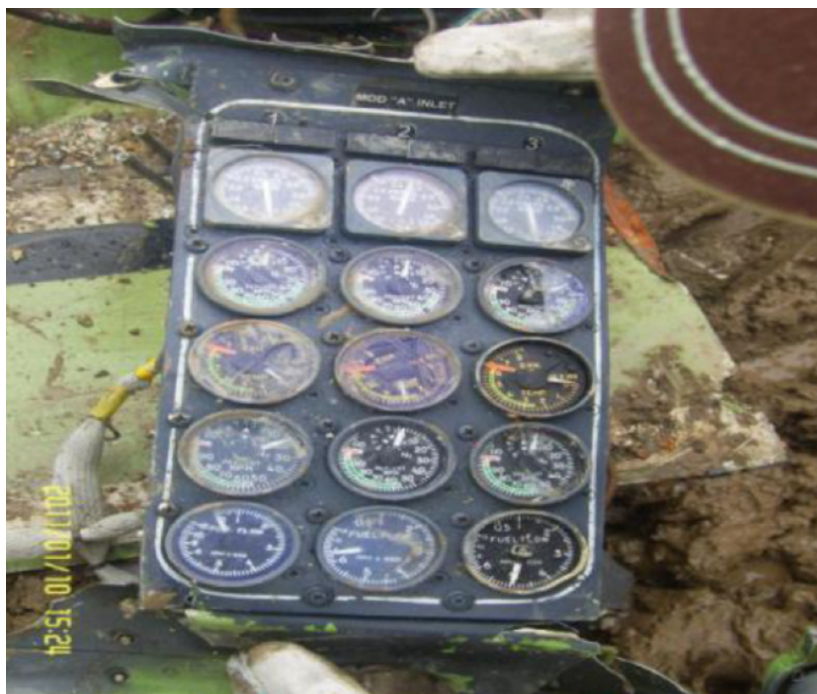
5. The image on the next page shows the engine instruments for all three engines. Initial investigations after the incident, considering the condition of the engine layers and the fuel flow rate, indicate that the fuel flow for engine 1 was almost zero, while it sharply decreased for engines 2 and 3. This created a preliminary assumption for the accident investigation team regarding the status of these two engines.

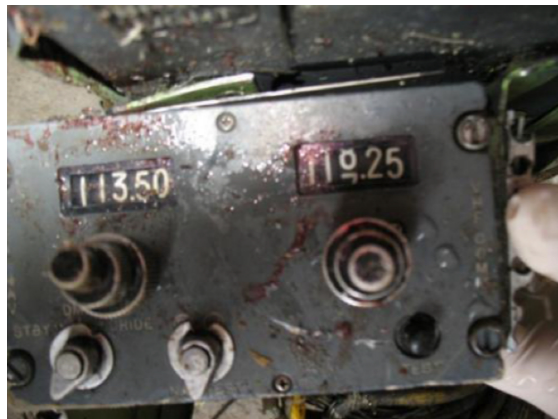
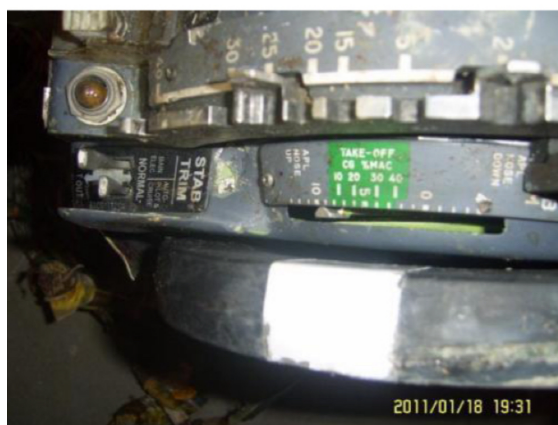
6. Figure 6 below shows that the right panel was set to the radio frequency of the Urmia Tower, but the Urmia VOR navigation system frequency was selected on the left panel. This indicates that, in the final moments, the Urmia VOR navigation system was shut down, and its antenna was no longer transmitting the radial signals.

Additionally, in photographs taken a week after the accident on another aircraft of the same model similar to aircraft EP-IRP, which was involved in the incident on 04/07/90—it was confirmed that this aircraft was equipped with two VHF panels with four windows. Two of these windows were for setting radio communication frequencies, while the other two were for setting the frequencies of VOR and ILS navigation systems.

7. The above figure shows the position of the Flap Lever, which is in the Up Position, and also displays the CG (Center of Gravity), which is in the lower part of the Green Band.
